Center for Riverine Science and Stream Re-naturalization

Field Trip Guide

Assessing Stream Restoration Success: Developing Sustainable Ecological and Physical Systems

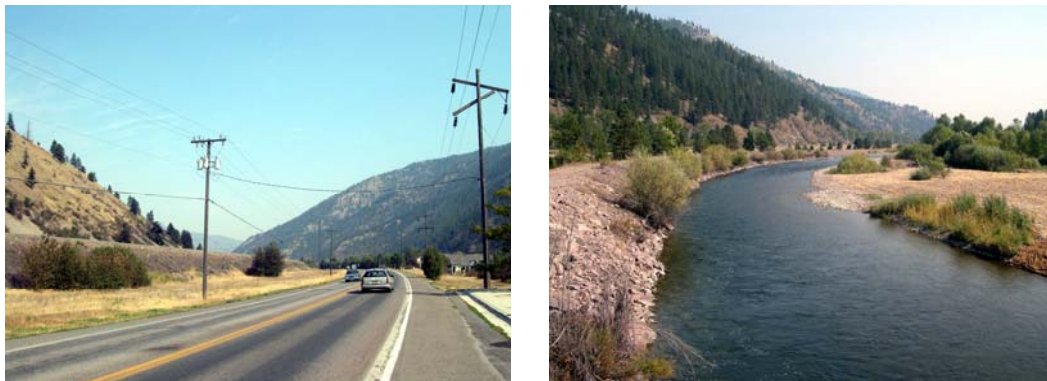
2 Enter the Clark Fork River Canyon (Hellgate Canyon just east of Missoula). The mountains to the north and south of the road are Mount Jumbo and Mount Sentinel, respectively. Both are composed of Precambrian argillites and quartzite of the Belt Super Group. You can see shorelines from glacial Lake Missoula on the southern slope of Mount Jumbo. Look for them throughout the trip today. Continue on and pass through the community of East Missoula. The community is partly founded on tan to pink Lake Missoula sediments.

Figure 3: Entering Hellgate Canyon and the Clark Fork River east of East Missoula, below Milltown Dam.

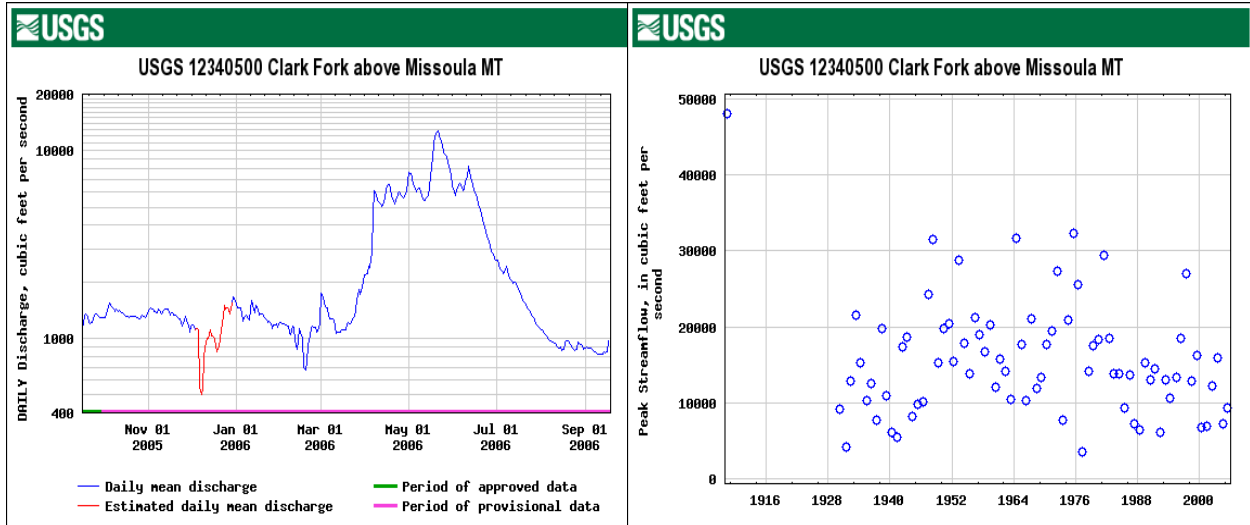
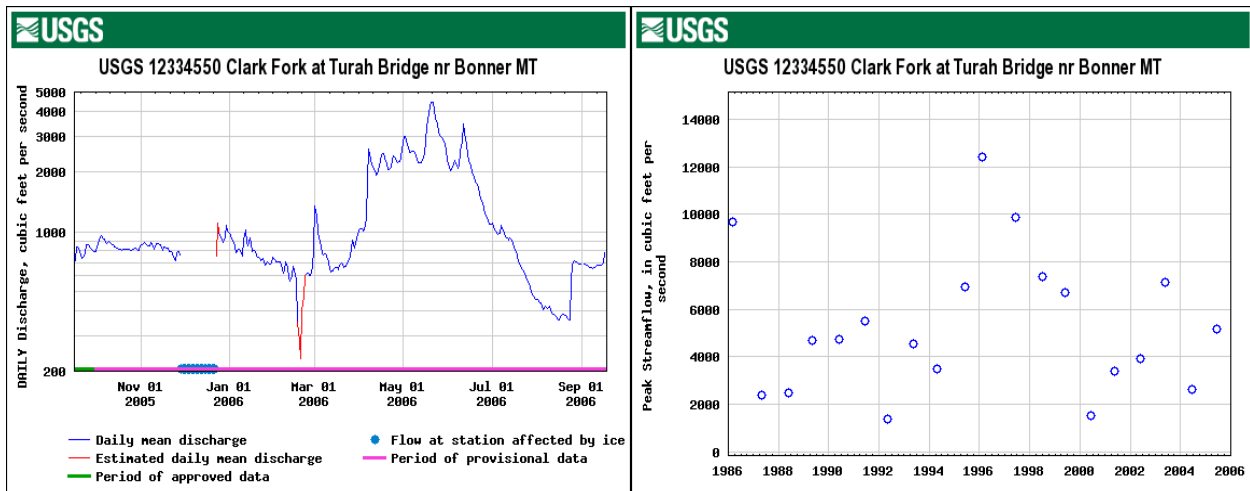
Figure 4: Stream flow hydrographs.

During the field trip you might want to examine stream hydrographs for the Clark Fork and Blackfoot Rivers. We have provided you the 2005 to 2006 hydrograph and peak stream flow data.

Below the Milltown Dam. USGS Station Above Missoula Clark Fork River.

Turah Bridge USGS Station on the CFR above the Milltown Reservoir

Blackfoot River about 11 km above the confluence with the CFR, USGS Gage.

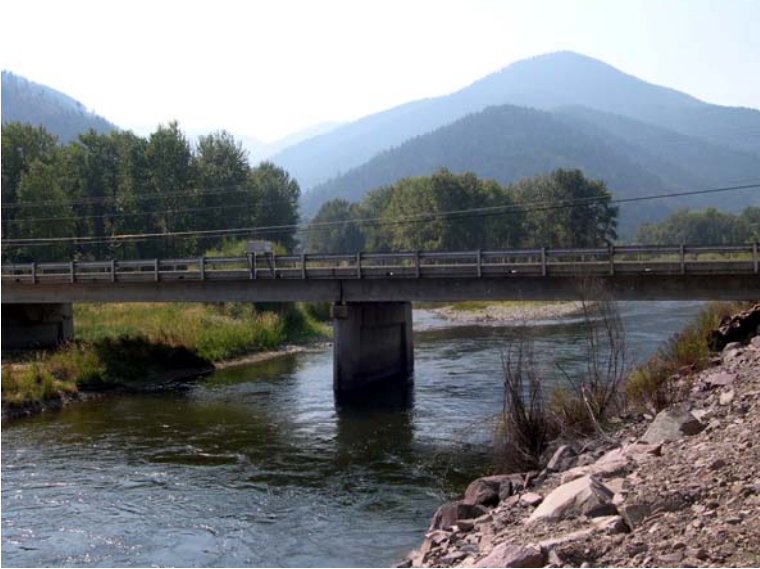
Figure 5: Turah Bridge and CFR looking west.

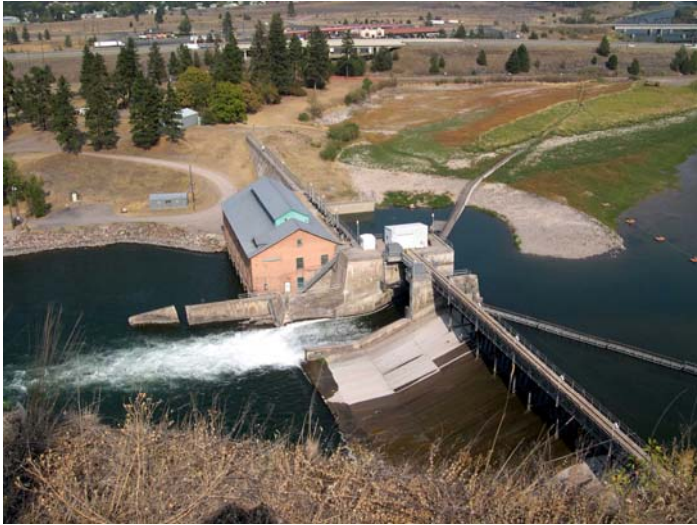
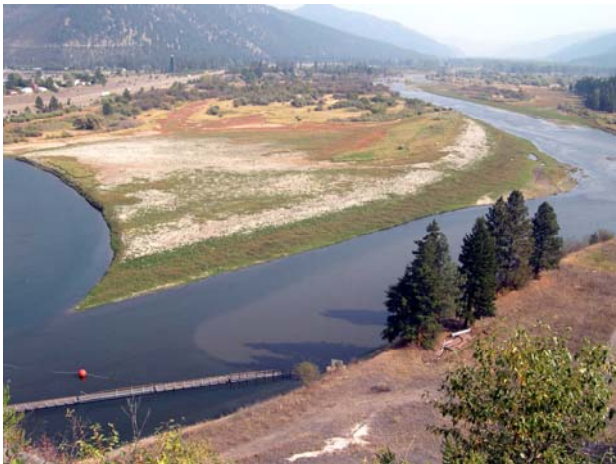
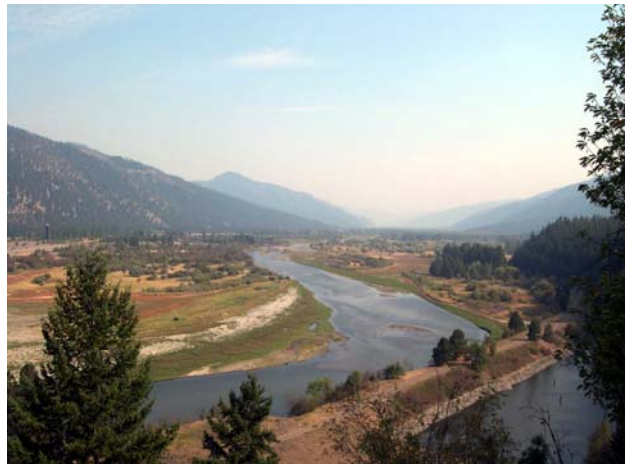
Figure 9: Milltown Dam, Area 1 Sediments exposed after an 8 ft drawdown (Summer 2006), and view looking southeast up the CFR from dam overlook.

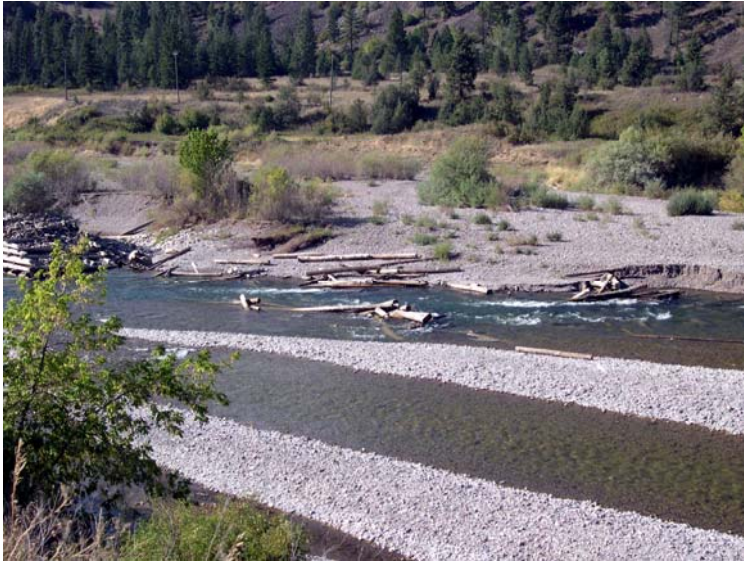
Figure 10: Blackfoot River head cut just up stream of the Bonner Mill.

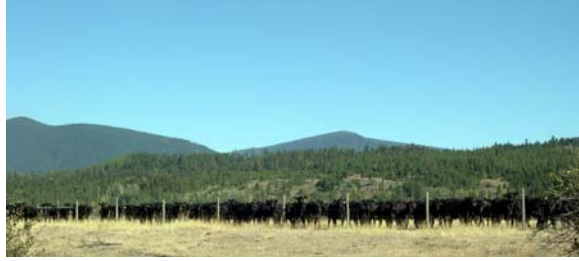
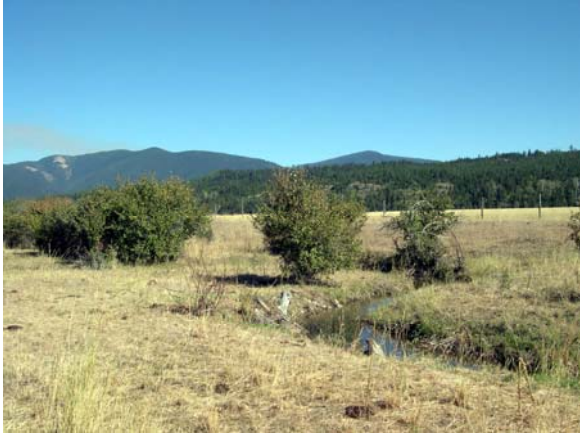
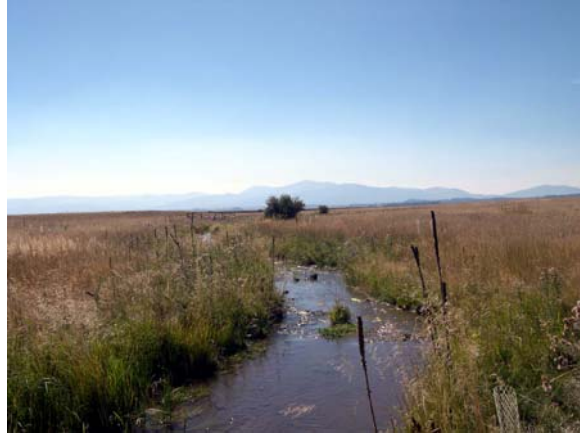
Figure 13: Rock Creek. Upstream “hard” restoration and downstream “soft” restoration. Cattle adjacent to restoration efforts.

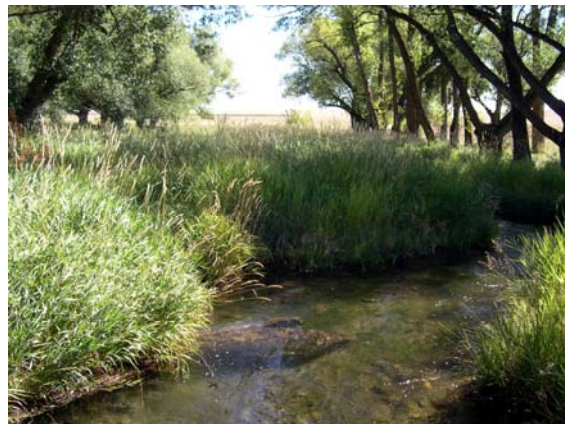
Figure 14. Kleinschmidt Creek Restoration.

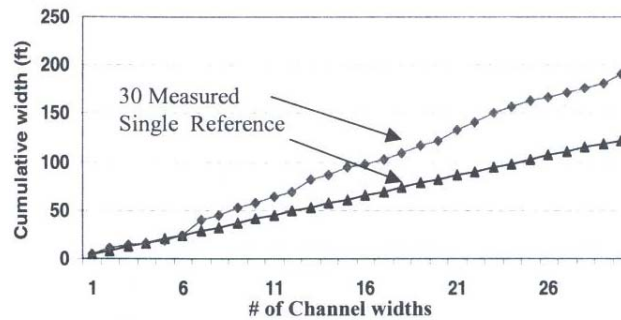
Figure 23. Cumulative bankfull width relationship for a reference and 30 measured channel widths.

“cumulative bankfull width” survey to calculate channel width characteristics of lower Hoyt Creek upstream of the spring. The survey is based on a stable (i.e. reference E-type) bankfull width and involves a systematic upstream survey of 30 bankfull widths at 10’ intervals beginning at the “reference” cross-section width. This

survey indicates the existing lower Hoyt Creek channel has a cumulative bankfull width approximately 50% wider than the cumulative reference condition (Figure 23). Based on observations, this widening is a function of hoof-shear damage.

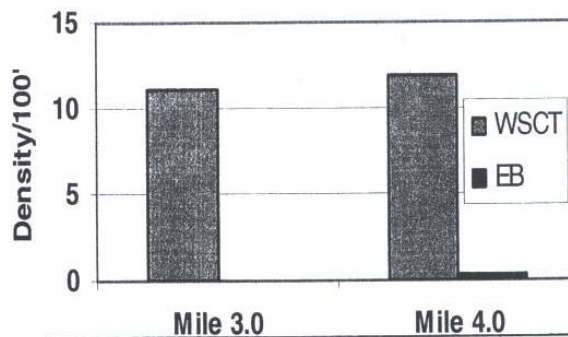
Figure 13. Densities of fish >4.0" at two sites in Ashby Creek, 2005.

In 2005, FWP established pre-project control (mile 4.0) and treatment (mile 3.0) fish population monitoring sections in order to measure the influence of the upcoming project (Figure 13). On August 8th, during the peak irrigation season we measured flows at 2.6 cfs above the diversion and 0.9 below the diversion. This 0.9 cfs downstream value is expected to approximate the minimum instream summer flows in the new channel.

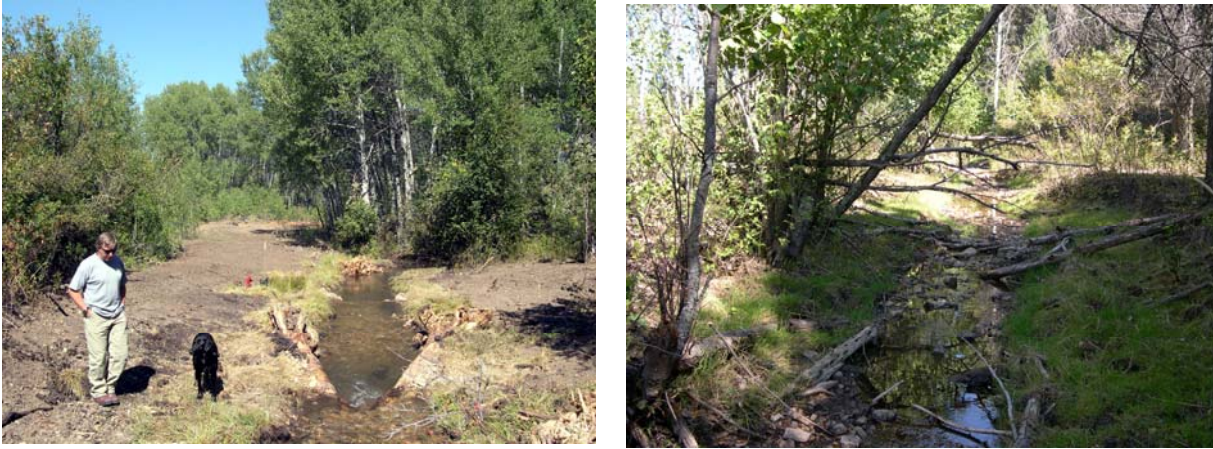
Figure 16: Ashby Creek Restoration and original channel.
