*Center for Riverine Science and Stream Re-naturalization*

**Fifth Annual Conference**

**“Ecology - when it comes to river restoration design, so what?”  
Field Trip Guide to Dunham Creek, Blackfoot River Watershed**

### Dunham Cr Project Background

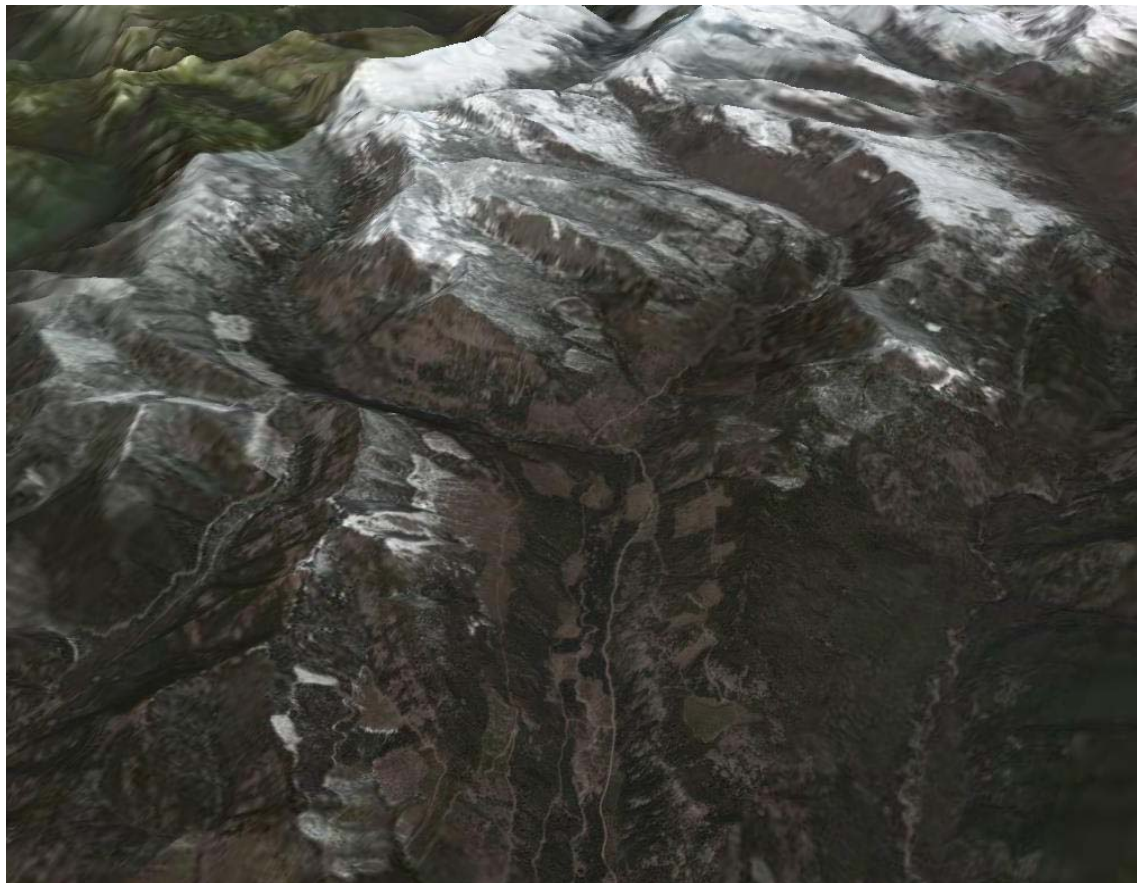
Figure 4: Google Earth view of Dunham Creek headwaters.

- ◆ High sediment input from upstream sources of high-relief Paleozoic and Proterozoic sedimentary rocks and Quaternary glacial deposits (Figure 4).
- ◆ Relatively high snow-melt runoff discharge followed by very low summer flows resulting in intermittent seasonal flows locally that act as barriers to fish passage (Figure 5).
- ◆ High sediment transport rates and large bedload of coarse-grained sediment.
- ◆ Sediment aggradation in the reach below the restored reach with potential downstream effects on irrigation withdrawal and flooding.

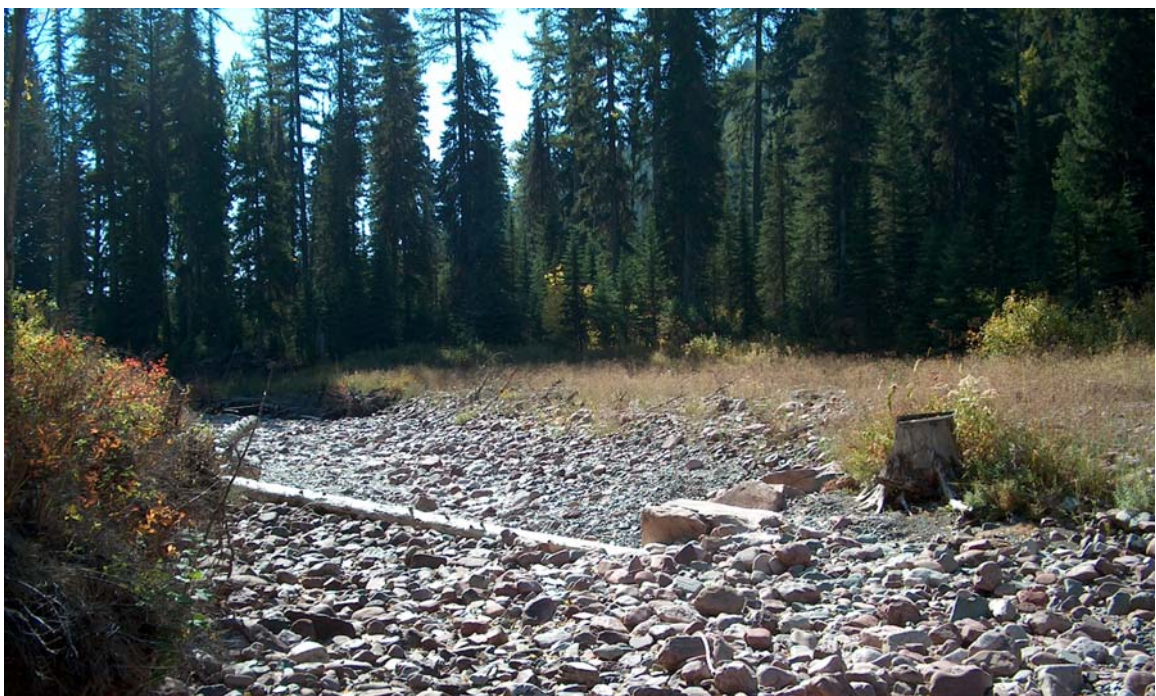
Figure 5: Late summer "low" flow within restored reach.

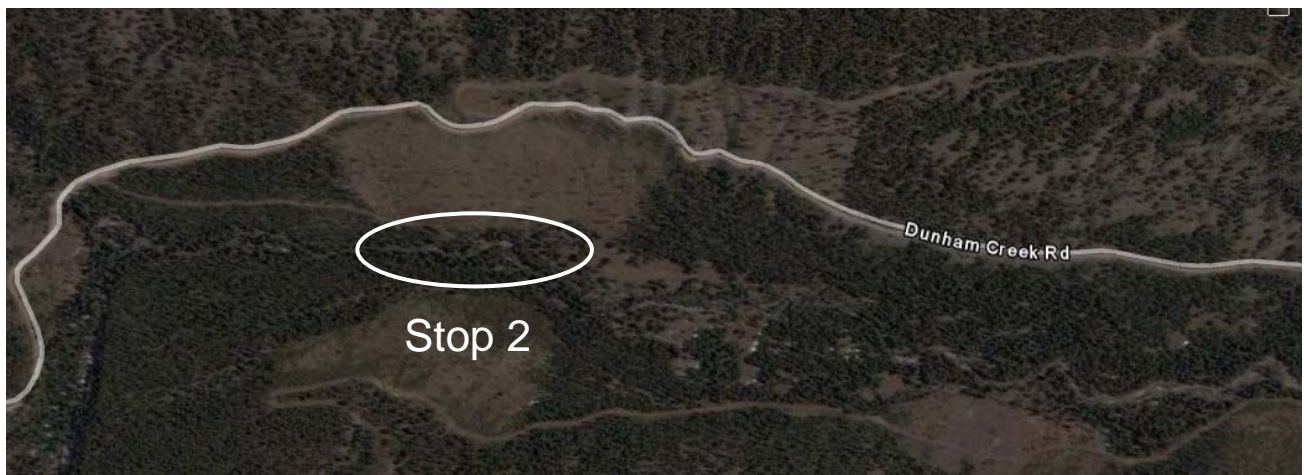
Figure 7: Google Earth image showing location of stop 2, reference reach area.

Leaving Monture Campground, we will drive north into Dunham Creek canyon. The first stop will be at a site above the restored reach to look at a reach of Dunham Creek used for a reference (Figure 8) in designing the restored channel farther downstream. We will walk along and in the creek channel for about a half mile to look at the channel characteristics, large woody debris, flow regimes, bed material, etc. The object is to have discussions on the important aspects of these cobble-boulder, high sediment transport streams in regards to important channel morphologic features, sediment transport, fisheries and ecosystem function. We will start out in one group but expect to break up into smaller groups as we wade downstream and clamber over and under log jams. Be prepared to wade and get wet. Walk back to the buses along the east side of the creek where a good game trail runs up the hill to the road.

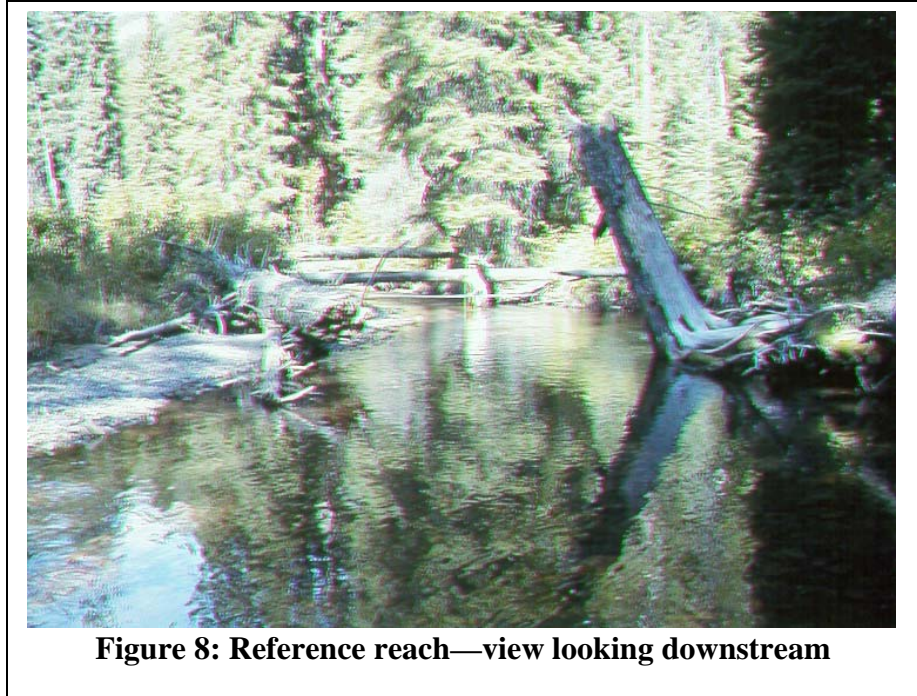
**Figure 8: Reference reach—view looking downstream**

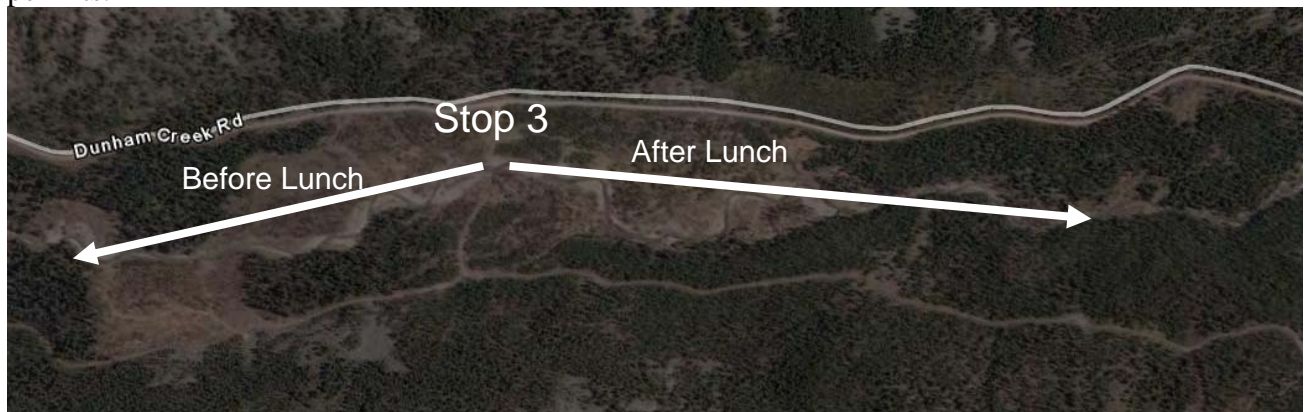
**Figure 8: Stop 3 at restored reach of Dunham Creek**

Return along the main dirt road. We will stop and park at the decommissioned bridge crossing site (approximate middle of project). First, we will discuss detailed project history, setting, objectives, design philosophy and rehabilitation techniques. The objectives of this stop will be to have a detailed discussion of channel rehabilitation techniques in the

context of sediment transport, channel migration to maintain a viable riparian ecosystem, the role of ground water, and overall approaches to maintaining connection to broader ecosystem issues as channels are designed and built on the reach scale. This is an excellent place to break into groups as we move through the reach and see various structures and talk about changes in the channel since construction. Before lunch, we will walk upstream about a quarter of a mile looking at channel and floodplain features. We will return to the buses for lunch. After lunch we will continue the discussion while we work our way downstream along the channel through the rehabilitated reach. We will discuss floodplain vegetation, channel migration, sediment transport and surface water-ground water interaction along this reach. We will continue along the channel until we get to the original stream channel, where we will discuss sediment transport and downstream issues related to sediment transport through the restored reach. We will work our way back north along the channel to the buses looking at riparian features along the way. Detailed maps and information will be provided at the stop. We will return to Missoula after this stop, possibly stopping at one more site if time permits.
