Combining historical and process perspectives to infer ranges of geomorphic variability and inform river restoration in a wandering gravel-bed river

ESPL

Earth Surface Processes and Landforms

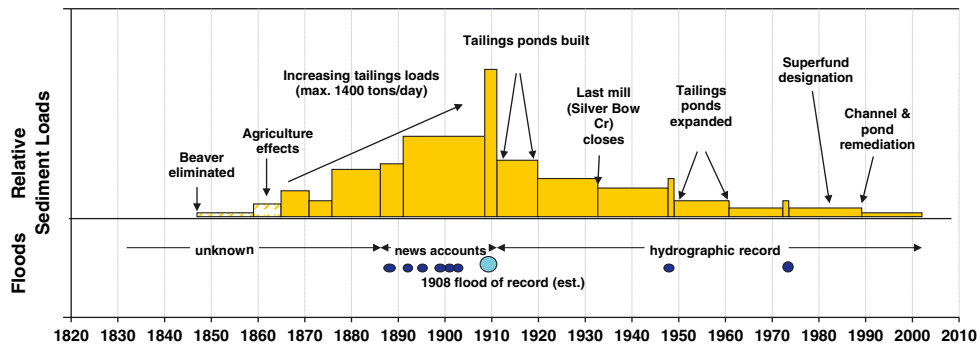
Figure 2. Timeline of relative sediment loads and floods affecting study reach, as an illustration of variations in sediment supply and transport capacity, constructed using review of mining history, data from agency reports, and data reported in Swanson (2002). This figure is available in colour online at wileyonlinelibrary.com/journal/esp

The mitigation period started in the 1910s when tailings ponds were built at the confluence of Warm Springs and Silver Bow Creeks (Figure 1) to reduce the flow of mining waste into the CFR (Quivik, 1998). The tailings ponds were expanded several times, through the 1990s (Hornberger *et al.*, 1997; Quivik, 1998). These impoundments block sediment delivery from 17% of the upper basin, and they likely caused substantial decreases in sediment loads in the upper CFR during the twentieth century compared to the mining era (Figure 2) (Moore and Luoma, 1990; Lauer and Parker, 2008).

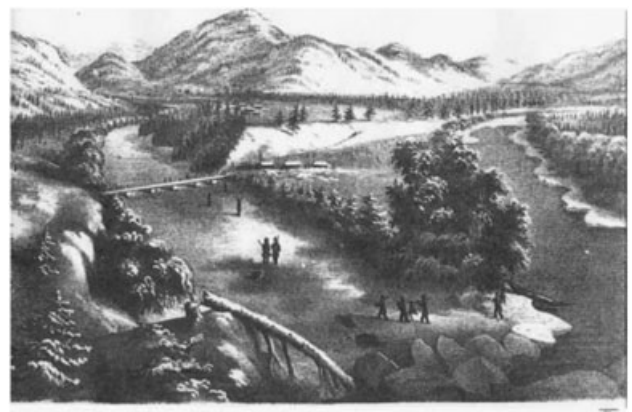
Figure 3. Lithograph of confluence of Clark Fork (on right) and Blackfoot (on left) Rivers produced by artist accompanying the Mullan expedition, 1860–1861. This image, the first known image of the downstream portion of the study area, illustrates single-thread channels at the confluence.

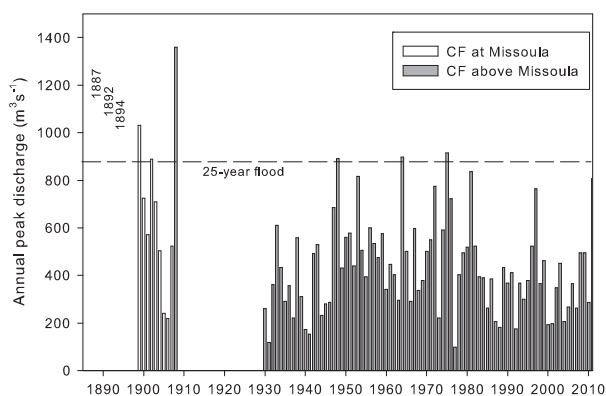
Figure 4. Peak flows on the Clark Fork River near Missoula, Montana. Columns show peak flows documented by the USGS at the Clark Fork (CF) at Missoula gauge (#12341500; 1899–1907) and CF above Missoula gauge (#12340500; 1908, 1930–2010). Year notations on upper left of graph illustrate estimated peak discharges in 1887, 1892, and 1894, which were ranked in terms of relative magnitude from newspaper accounts and in comparison to the post-1899 measured discharges; the exact magnitude of these events is not known (Wheeler, 1974). The 25-year flood magnitude for gauge #12340500 (Parrett and Johnson, 2004) is shown to illustrate the frequency of such events in the 1887–1908 period (6 > 25-year events) versus in the 1930–2010 period (3 > 25-year events).

Hard-rock mining for copper in the headwaters boomed in the late 1870s, and the Butte area became the world's most productive mining district for three decades (Quivik, 1998). Hundreds of millions of cubic meters of contaminated tailings (silt to fine-sand), the material that is discarded when milling and flotation are used to separate ore (Moore and Luoma, 1990), were dumped into the CFR headwaters. A series of large floods in the late nineteenth and early twentieth centuries (Figure 4) coincided

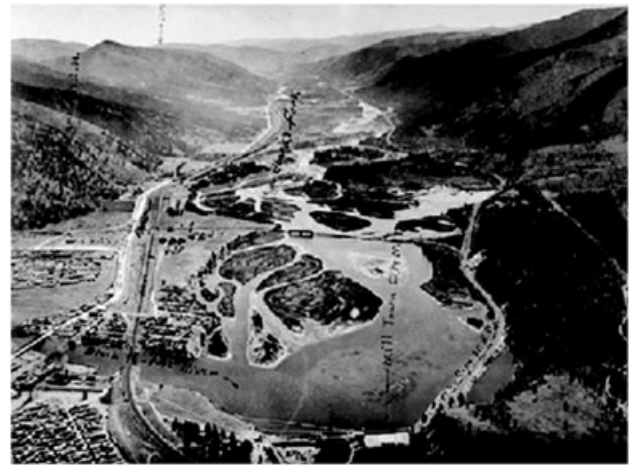
Figure 6. 1930s view of the study area under high-flow conditions looking upstream. Milltown Dam is center bottom, Blackfoot River enters at lower left, and a multi-thread channel is visible upstream of the bridge spanning the channel in the center of the photograph. This figure is available in colour online at wileyonlinelibrary.com/journal/espl

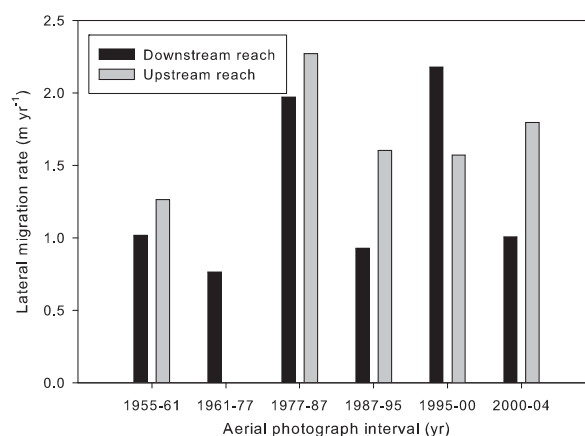
Figure 9. Lateral migration rates calculated from aerial photograph analysis for two study segments, located in the downstream and upstream portions of the study reach.

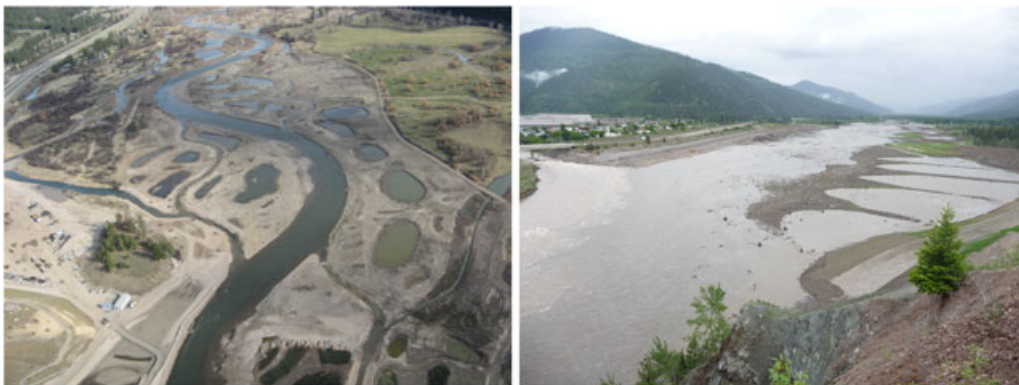
Figure 10. Milltown restoration reach. Left image shows newly constructed channel in April 2011 (courtesy of G. Matson); right image shows restoration reach in June 2011 at high flows; former Milltown Dam site is in lower left (courtesy of J. Bean). This figure is available in colour online at wileyonlinelibrary.com/journal/espl
